Shelling of the town of Kirovsk using Grad MLRS on February 7, 2015.

PUBLIC INVESTIGATION

Donetsk 20.03.2022

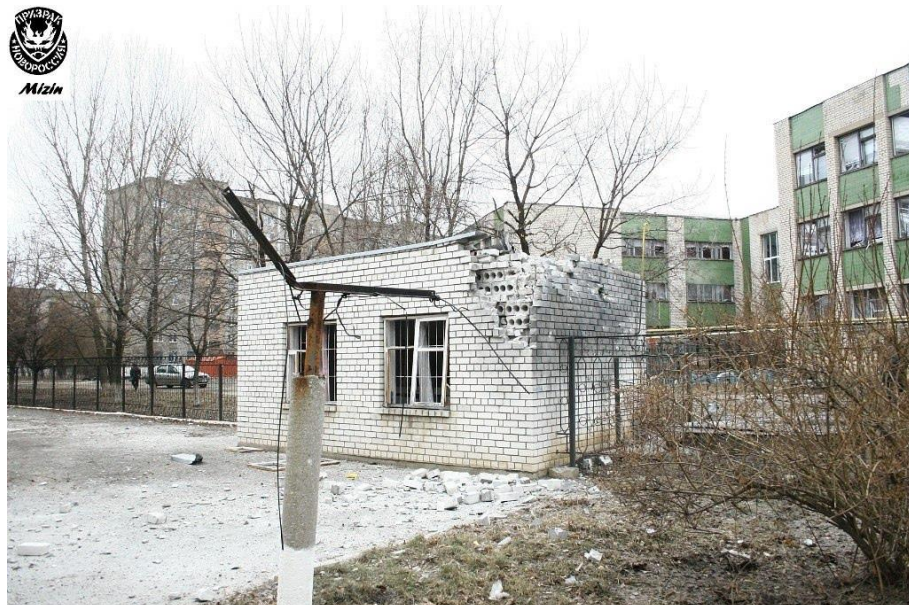
Fig. 2 – Destroyed eastern corner of the boiler station roof as a result of shell hit 1²⁴.

Shell hit 1 (see Fig. 2). The shell hit the eastern corner of the roof of the boiler station, located between school No. 2 (at 23, 60 years of October Quarter) and kindergarten No. 4 "Nadezhda" (at 24, 60 years of October Quarter). As a result of the projectile detonation, part of the roof and the wall near the eastern side of the building was destroyed. Also, equipment was partially destroyed and damaged inside the boiler station⁷.

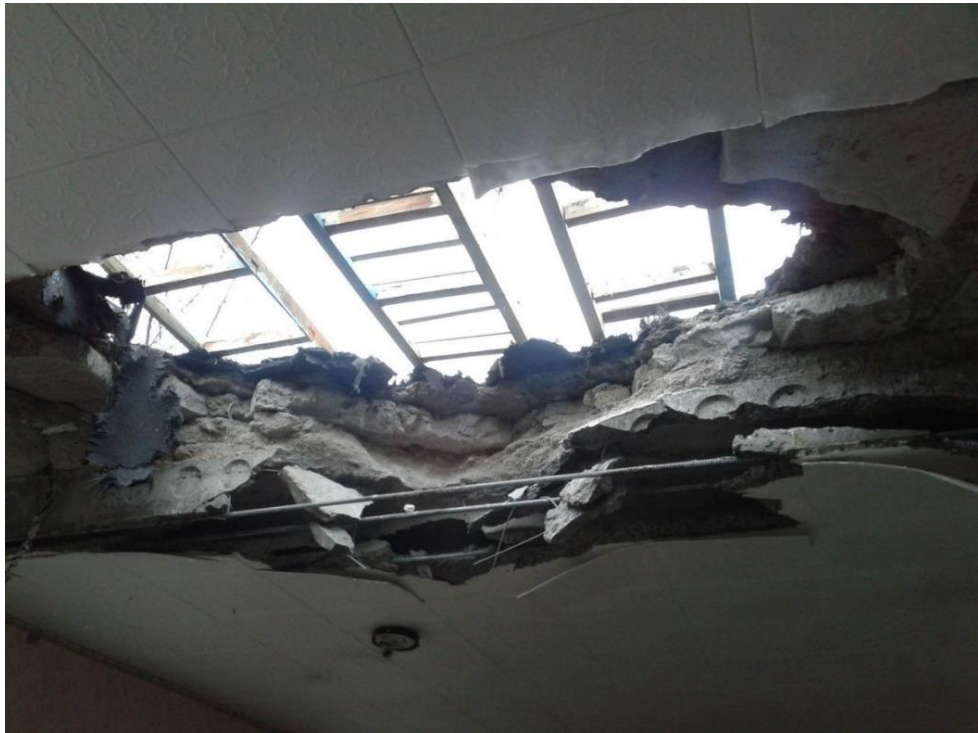
Fig. 3 – The through hole in the roof of the kindergarten as a result of shell hit 2²⁵.

Shell hit 2 (see Fig. 3, Fig. 4, Fig. 5). The shell hit the roof in the central part of the building of kindergarten No. 4 "Nadezhda" (at 24, 60 years of October Quarter). As a result of the projectile detonation, a through hole was formed in the roof, part of the ceilings of the kindergarten music hall collapsed, causing damage to the premises.

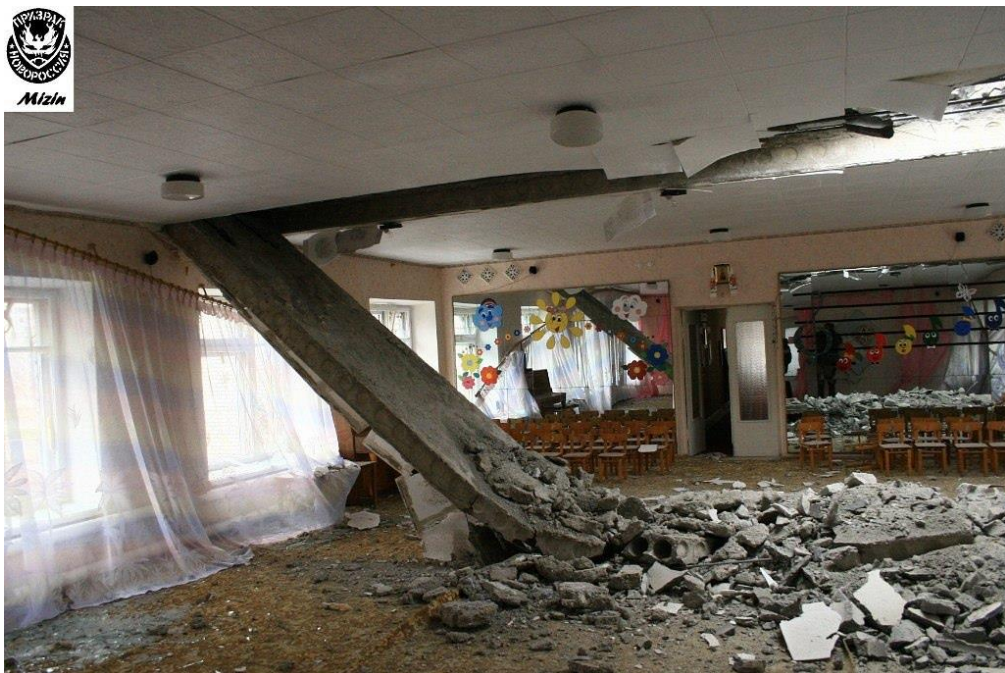
Fig. 4 -The ceiling of the music hall of the kindergarten collapsed as a result of shell hit 2²⁶.

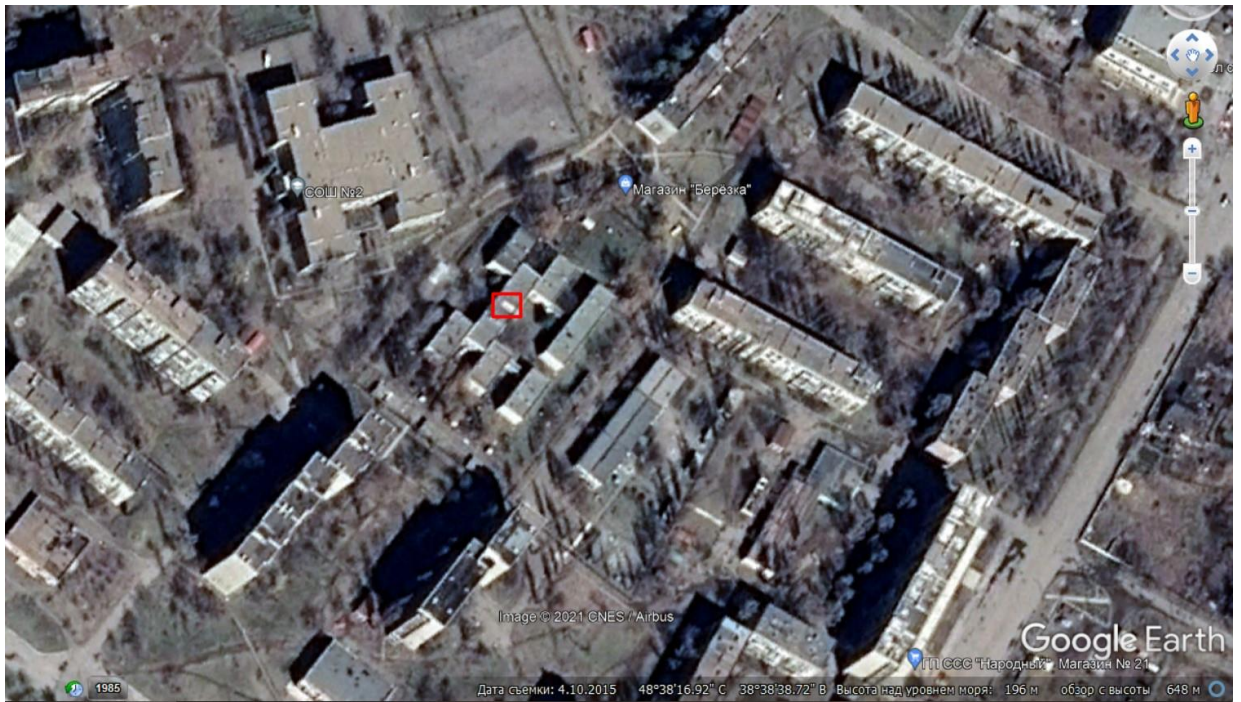
Fig. 5 – The trail of a shell hit 2 on the kindergarten roof on the satellite image dated 10.04.2015.

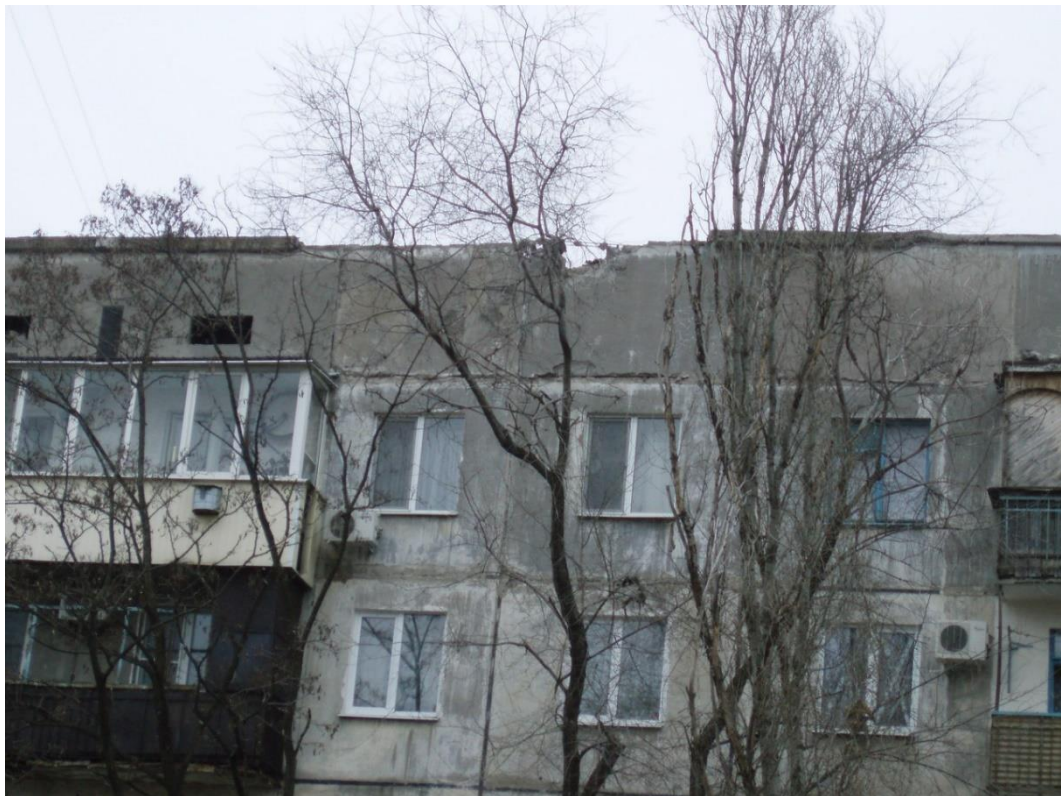
Fig. 6 – The roof damaged by shell hit 3²⁷.

Shell hit 3 (see Fig. 6). The shell hit the northern part of the roof of residential building No. 4, 60 years of October Quarter, near the third entrance. As a result of the projectile detonation, the roof was damaged a few meters south-west of the northern corner of the building.

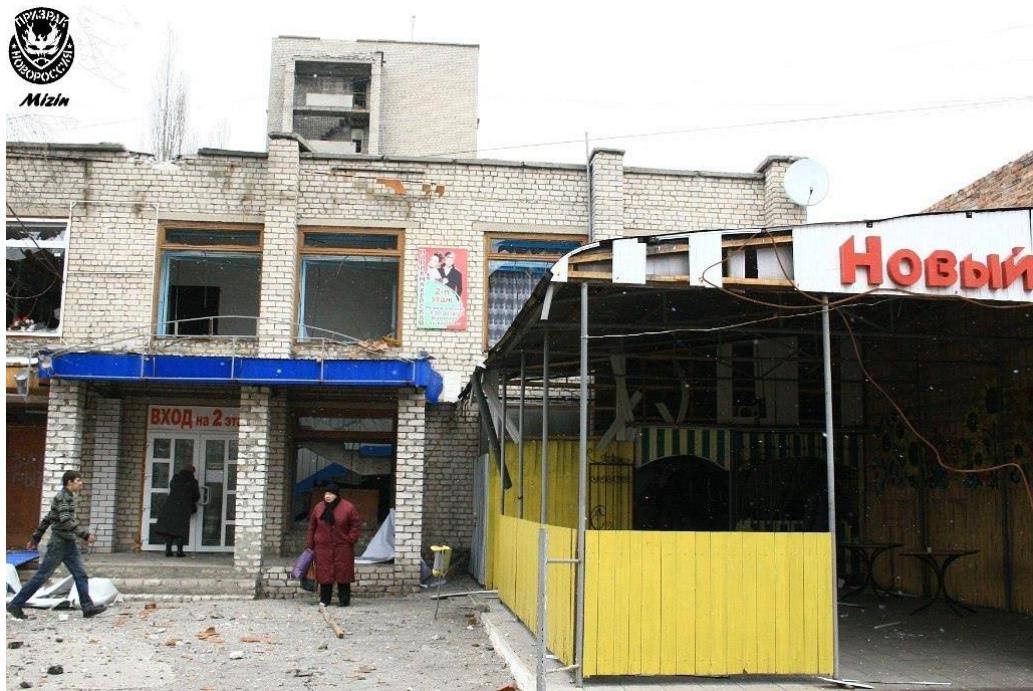
Fig. 7 – The roof of the Kirovchanka consumer services center damaged by shell hit 4²⁸.

Shell hit 4 (see Fig. 7, Fig. 8). The shell hit the roof of *Kirovchanka* consumer services center (at 3A, 60 years of October Quarter). As a result of the projectile detonation, part of the roof was destroyed.

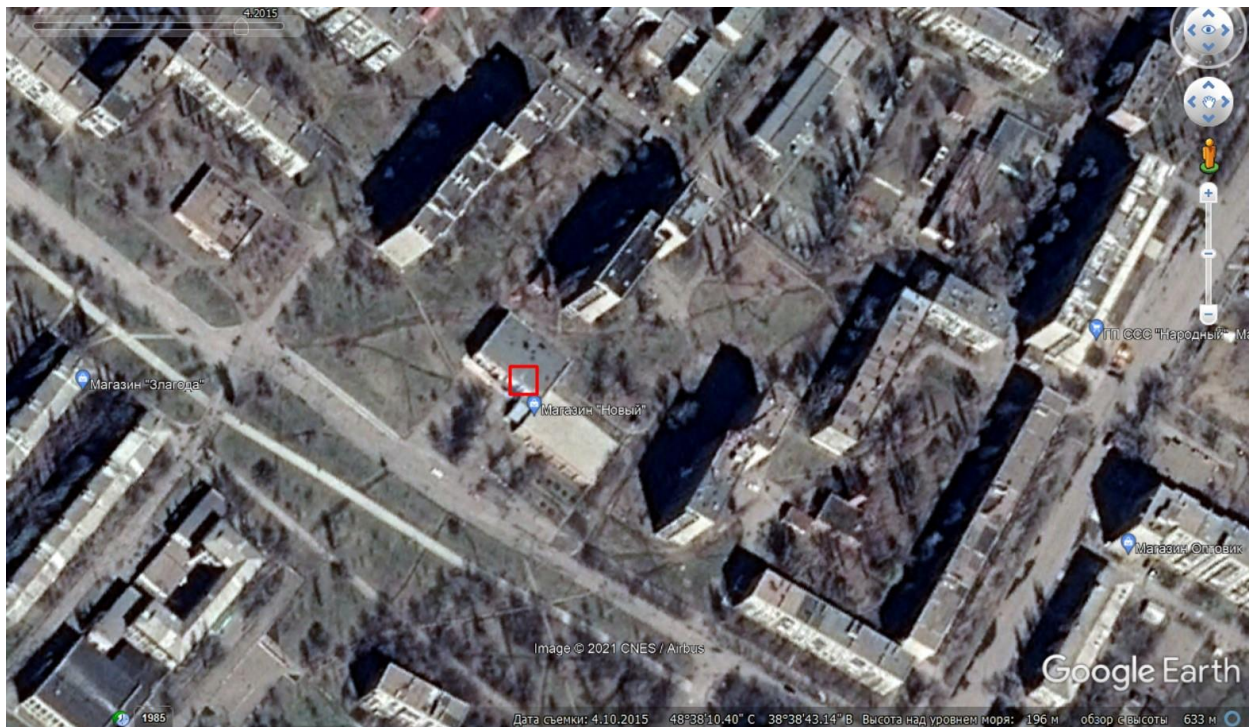
Fig. 8 – The trail of a shell hit 4 in the roof of Kirovchanka consumer services center on the satellite image dated 10.04.2015.

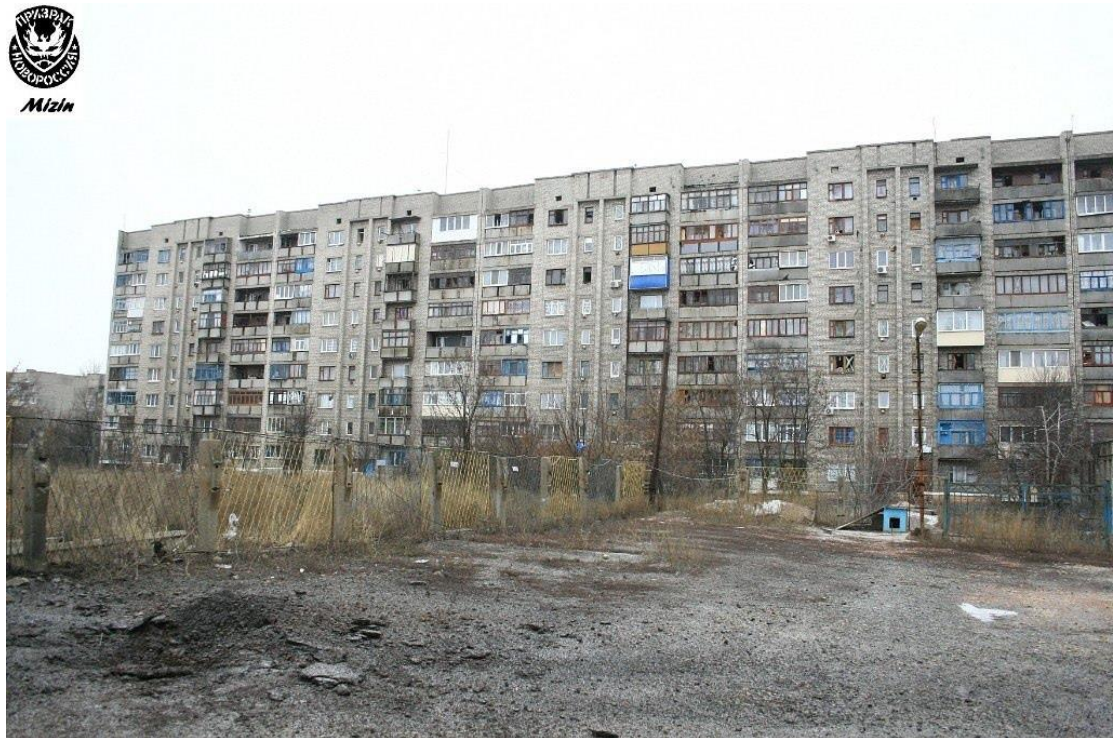
Fig. 9 – The shell crater found at the site of shell hit 5²⁹.

Shell hit 5 (see Fig. 9, Fig. 10). The shell hit the ground surface in the car parking area, about 50 meters north-east of the eastern corner of the building extension at 10, XXIII Party Congress Street. The projectile detonation resulted in a shell crater in the ground near the safety fencing.

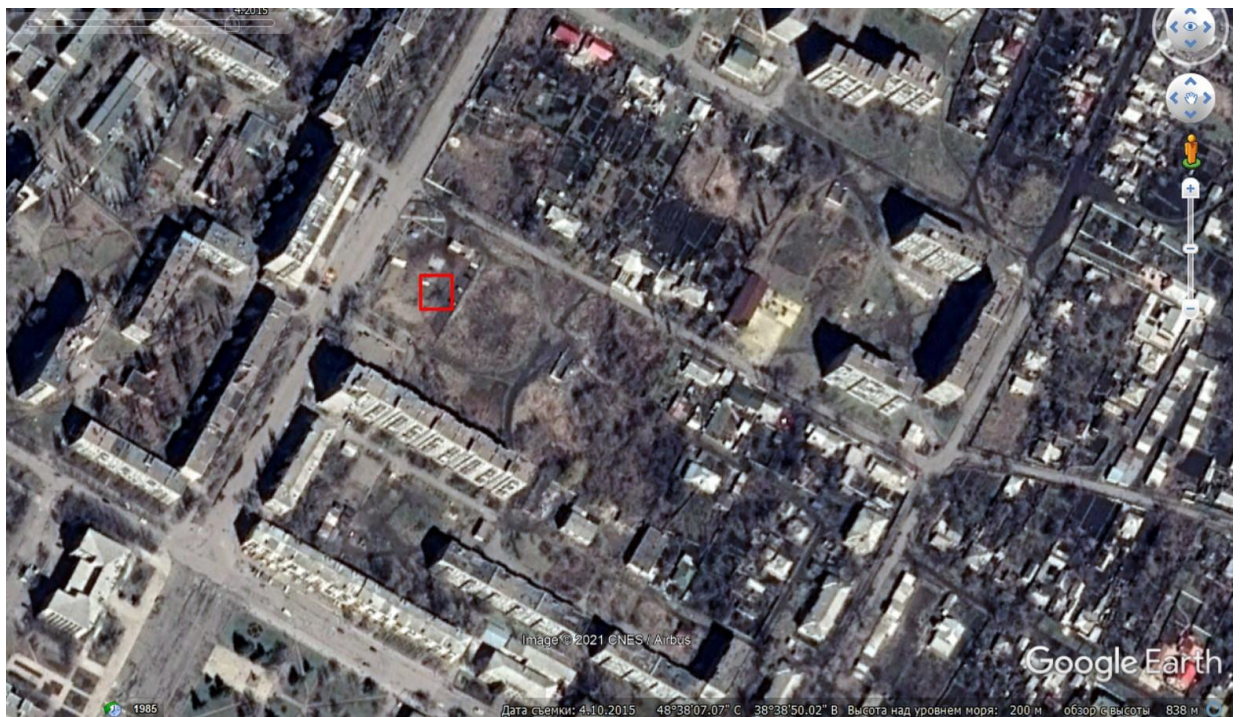
Fig. 10 – The trail of shell hit 5 on the satellite image dated 10.04.2015.

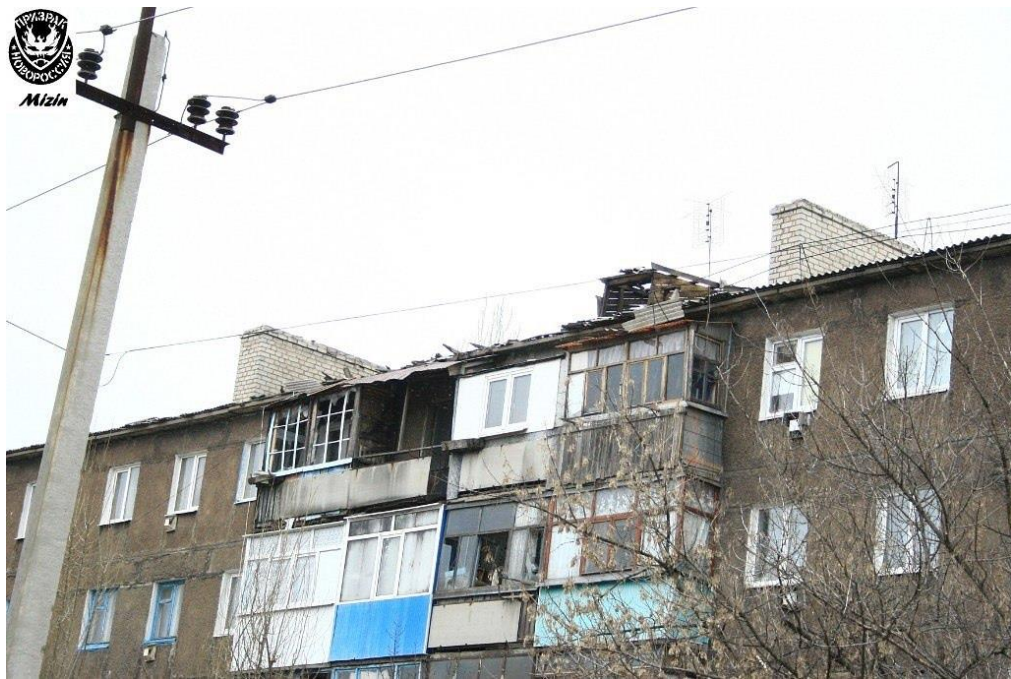
Fig. 11 – View of the roof destroyed as a result of shell hit 6³⁰.

Shell hit 6 (see Fig. 11, Fig. 12, Fig. 13, Fig. 14). The shell hit the roof of residential building about several meters to the south-east of the southern corner of residential building No. 12 in 50 Years of the USSR Quarter. As a result of the projectile detonation, part of the roof near the southern corner of the building was destroyed, a through hole was formed in the ceiling slab. Metal fragments of the missile part (hereinafter referred to as MP) of the MLRS rocket were found at the shell hit site.

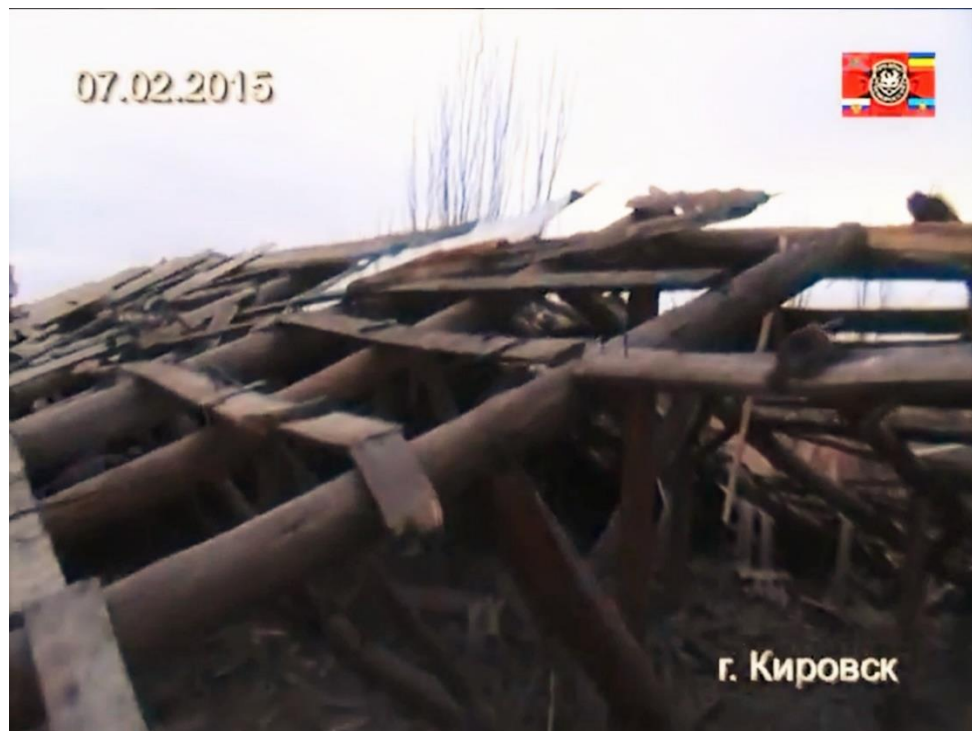
Fig. 12 – The roof damaged by shell hit 6³¹.

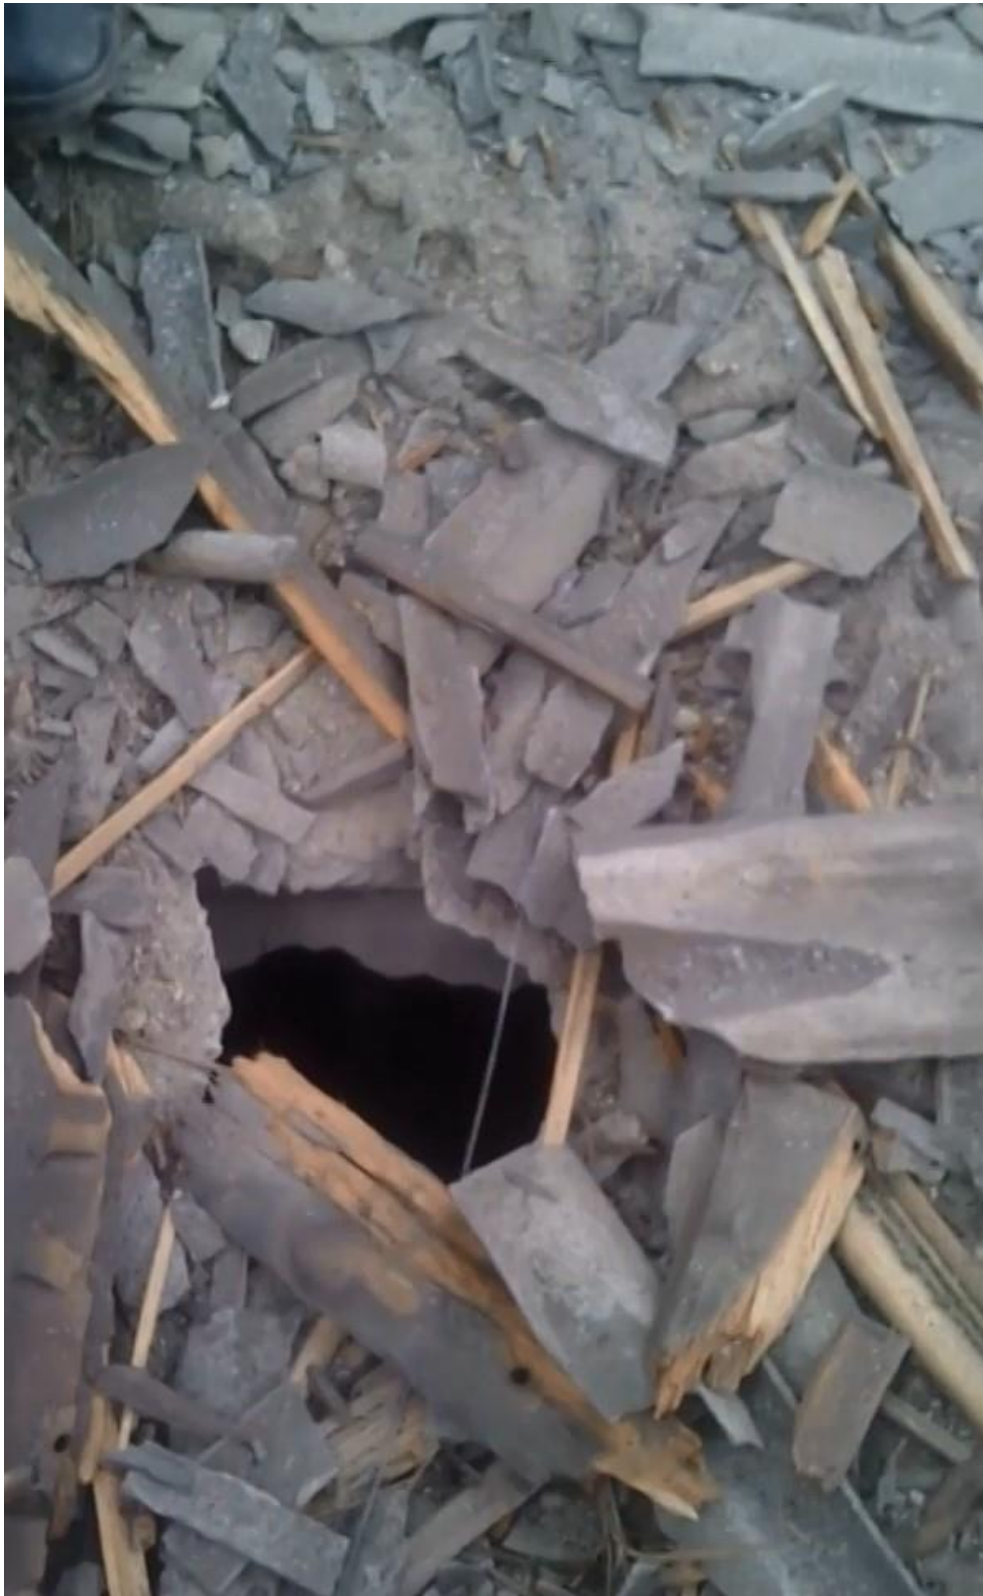
Fig. 13 – The shell crater found at the site of shell hit 6³².

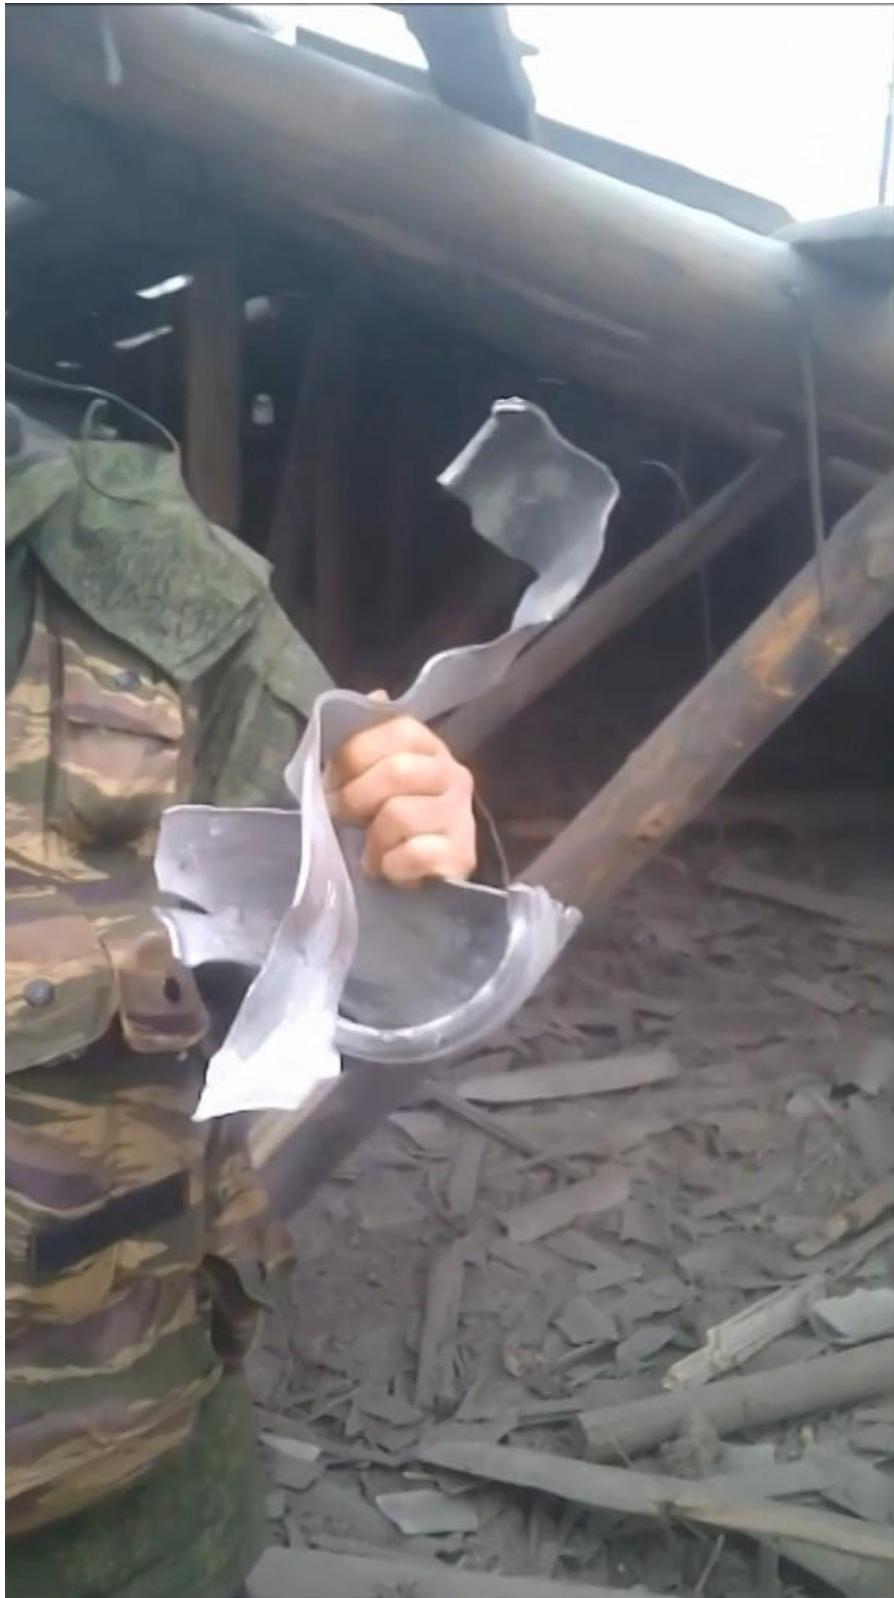
Fig. 14 - Metal fragments of an MLRS projectile MP, found at the site of shell hit 6³³.

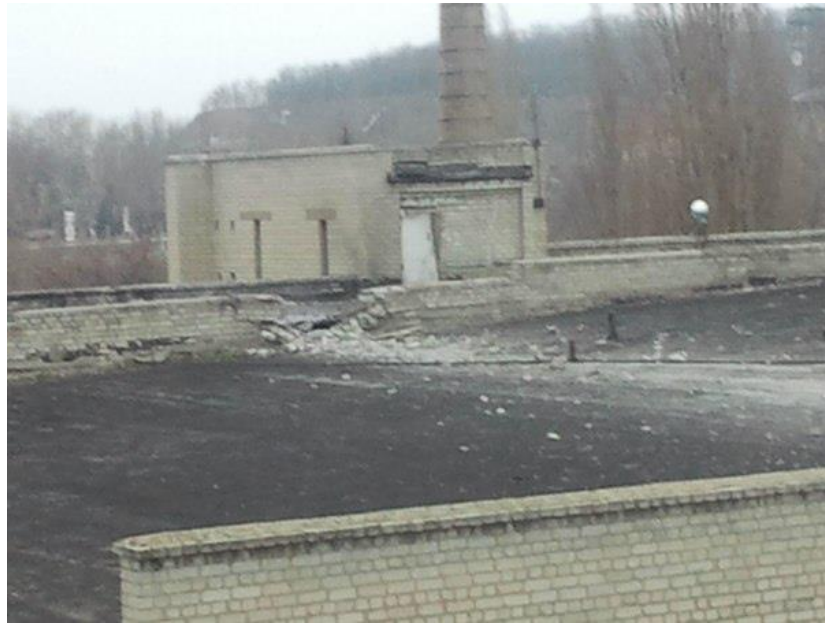
Fig. 15 – The roof of the technical college damaged by shell hit 7³⁴.

Shell hit 7 (see Fig. 15, Fig. 16, Fig. 17, Fig. 18, Fig. 19). The shell hit the roof of the south-western building of the technical college (at 10, Borisova Str.). As a result of the projectile detonation, the roof near the south-eastern wall of the building was destroyed, a through hole was formed in the roof, part of classroom ceilings collapsed, damaging the premises.

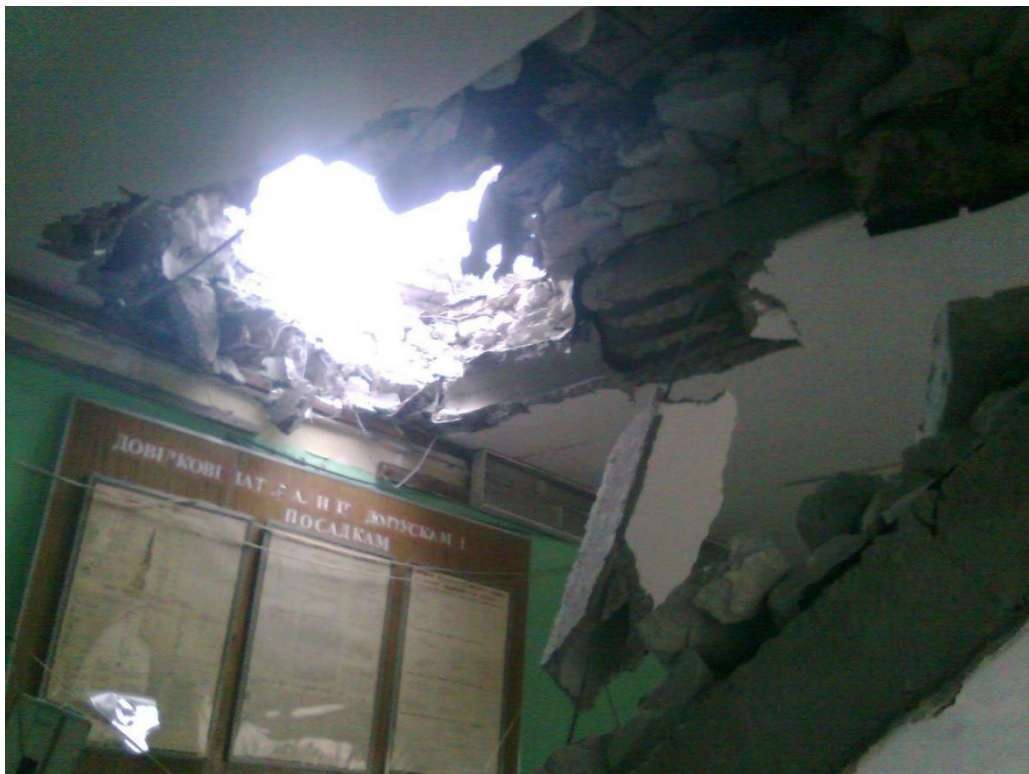
Fig. 16 – The through hole in the roof of the technical college damaged as a result of shell hit 7³⁵.

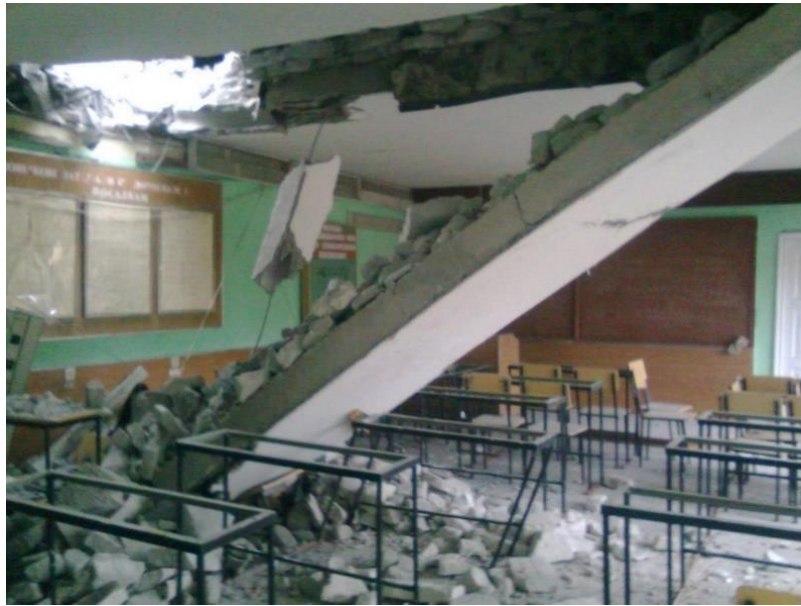
Fig. 17 – Ceiling of the training class in the technical college, which collapsed as a result of shell hit 7³⁶.

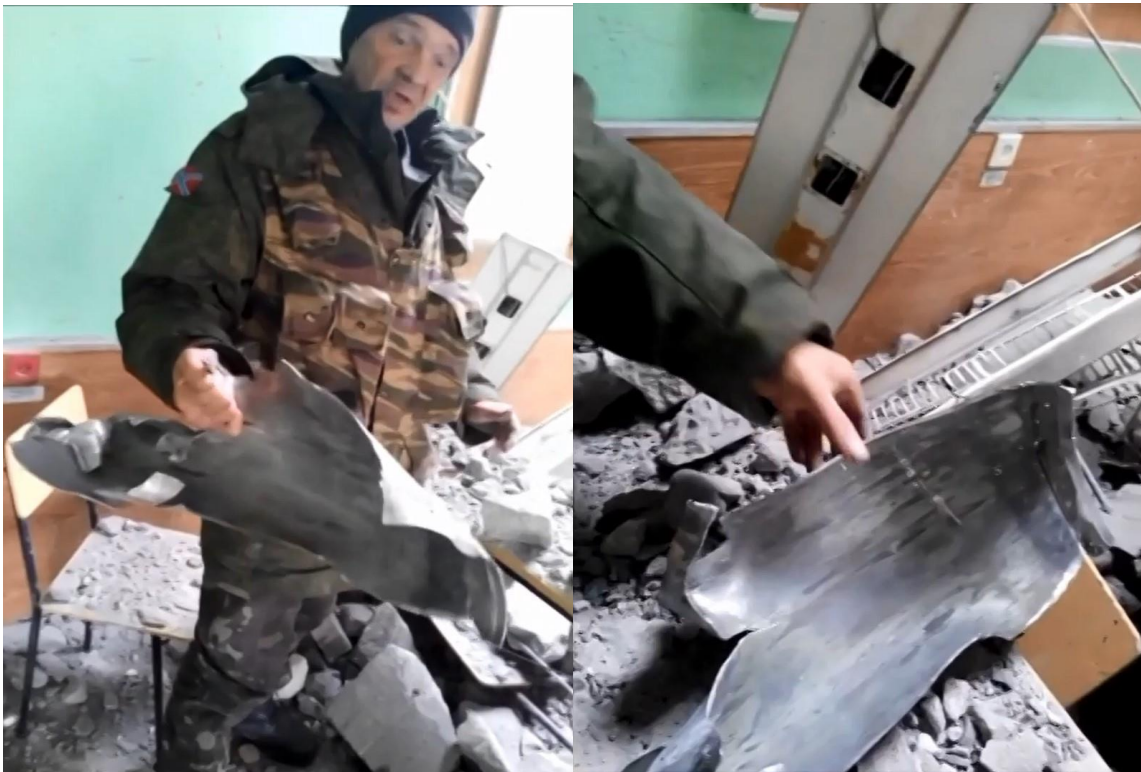
Fig. 18 - Metal fragments of a MLRS projectile MP found at the site of shell hit 7³⁷.

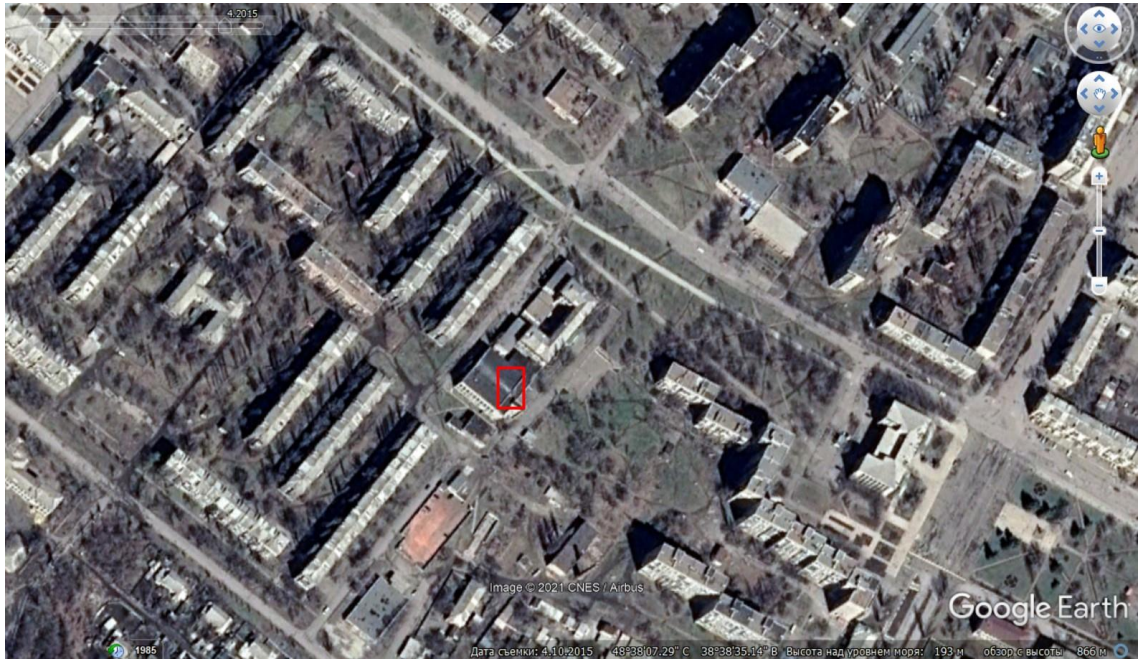
Fig. 19 – The trail of shell hit 7 in the roof the technical college on the satellite image dated 10.04.2015.

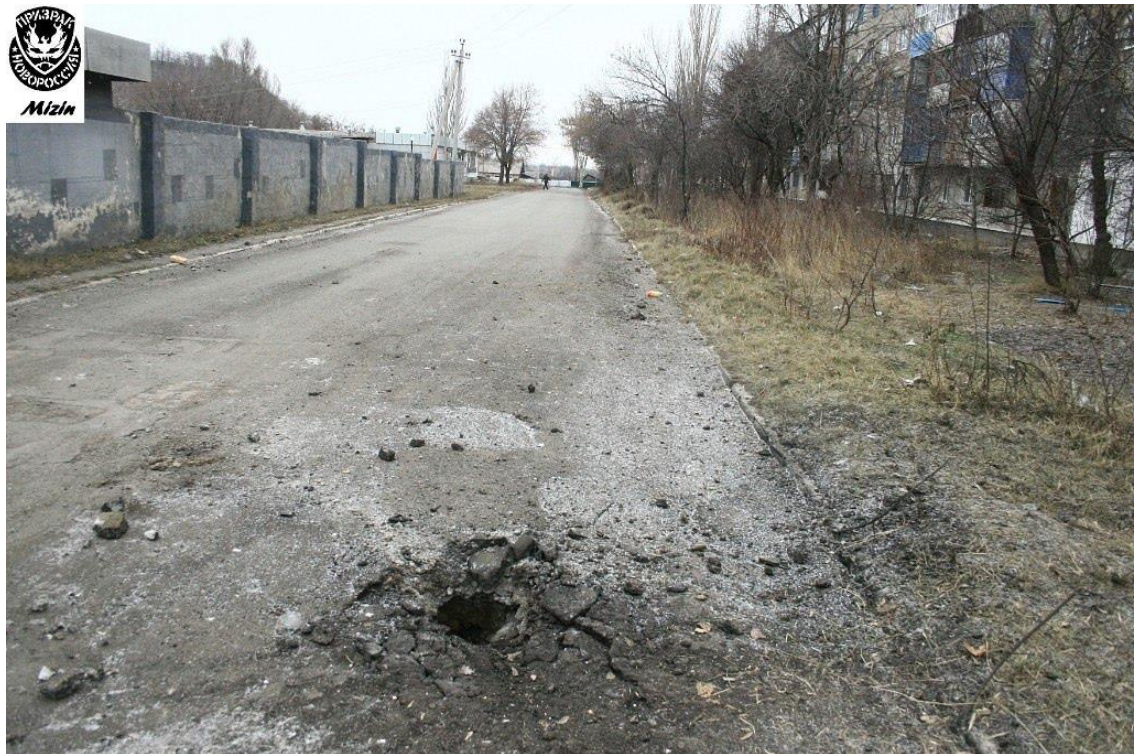
Fig. 20 – A crater from shell hit 8³⁸.

Shell hit 8 (see Fig. 20). The shell hit the asphalt surface about 20 meters to the south of the western corner of residential building No. 1 in 50 Years of the USSR Quarter. The projectile detonation resulted in a shell crater in the asphalt pavement.

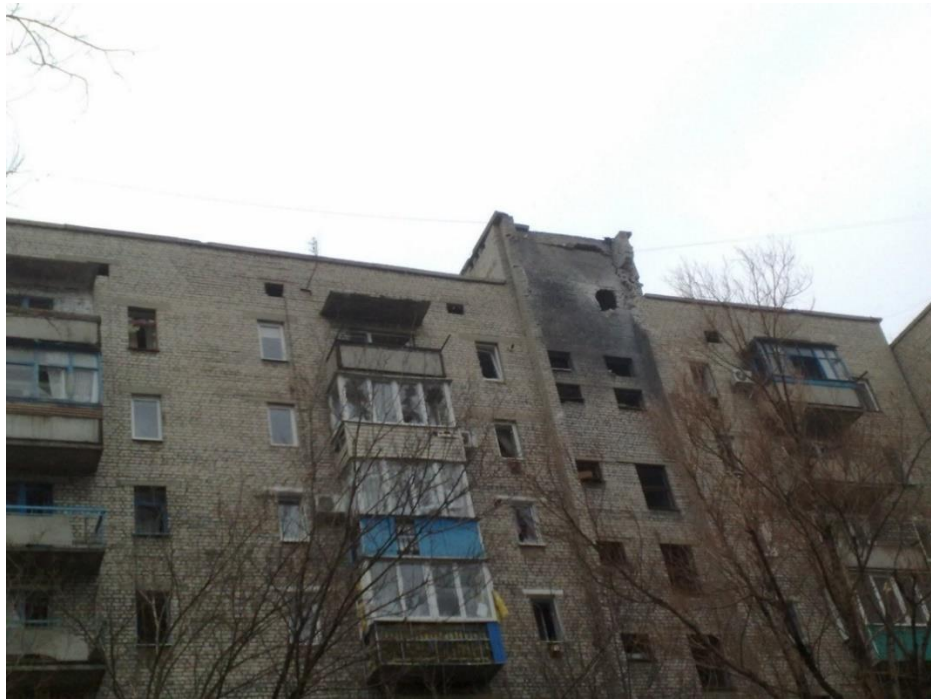
Fig. 21 – The through hole in the wall of the residential building as a result of shell hit 9³⁹.

Shell hit 9 (see Fig. 21, Fig. 22). The shell hit the northern wall of the residential building at 3A, Poguleeva Str. As a result of the projectile detonation, a through hole was formed in the wall at the level of the attic floor, a few meters to the north-west of the second entrance. The MP remains of an MLRS projectile were found near the shell hit site.

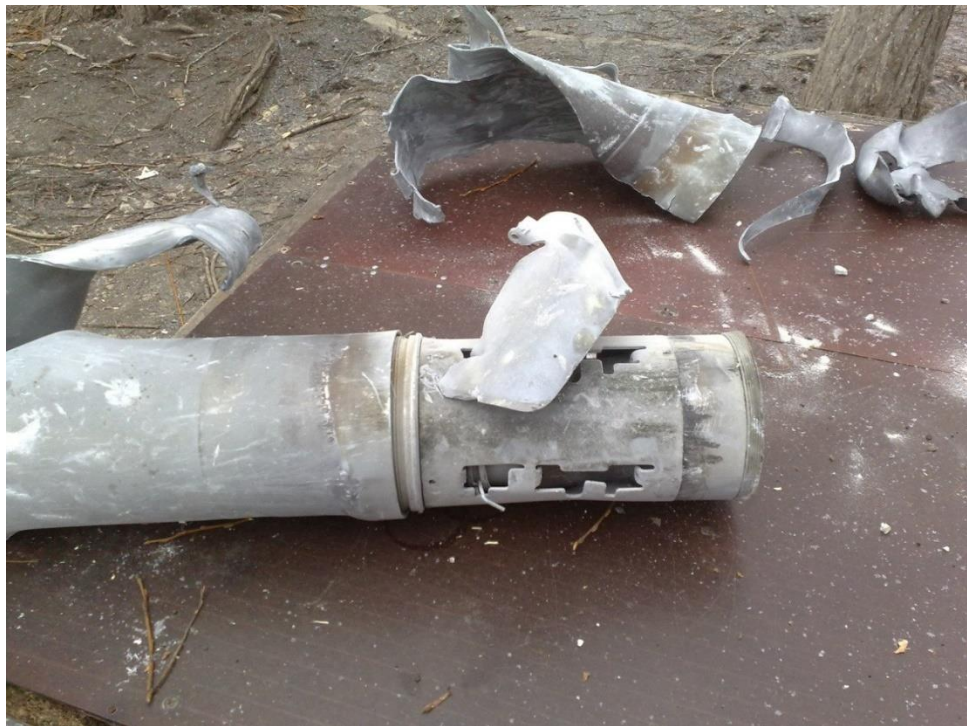
Fig. 22 - MP remains of a MLRS projectile in a crater found at the site of shell hit 9⁴⁰.

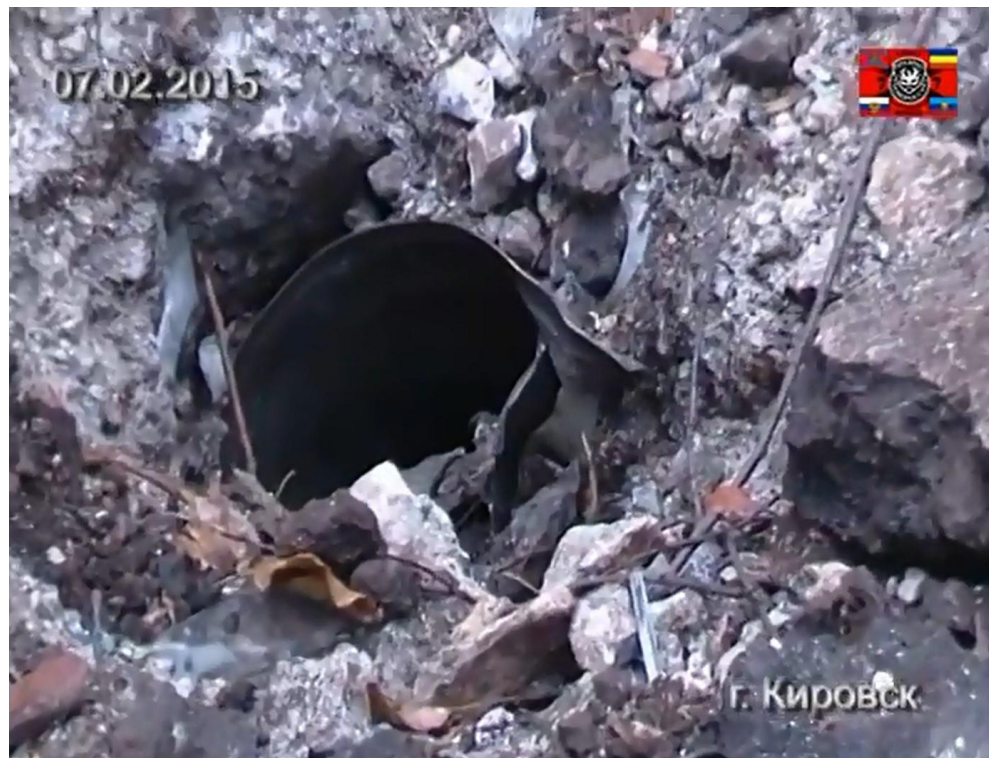
Fig. 24 – A crater with the remains of a MLRS projectile MP created as a result of shell hit 10⁴².

Shell hit 10 (see Fig. 23, Fig. 24). The shell hit the ground surface between the second and third entrances, a few meters from the residential building at 3A, Poguleeva Str. The projectile detonation resulted in a shell crater in the ground with metal fragments in the crater center, identified as the remains of the MLRS projectile MP.

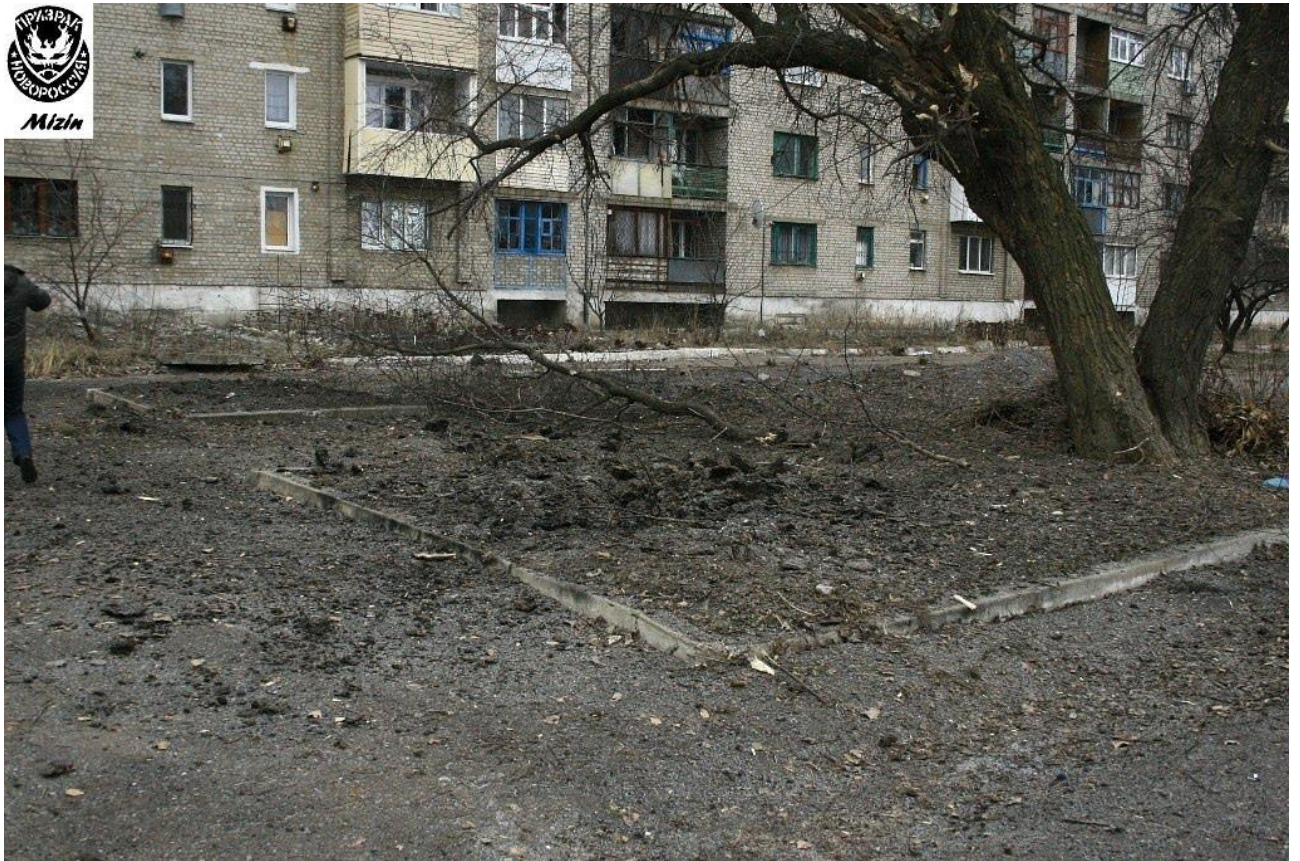
Fig. 25 – A crater from shell hit 11⁴³.

Shell hit 11 (see Fig. 25). The shell hit the ground surface northern from the back of the residential building at 3B, Poguleeva Str. As a result of the projectile detonation, a crater was created in the ground about 12 meters south-west of the northern corner of the building.

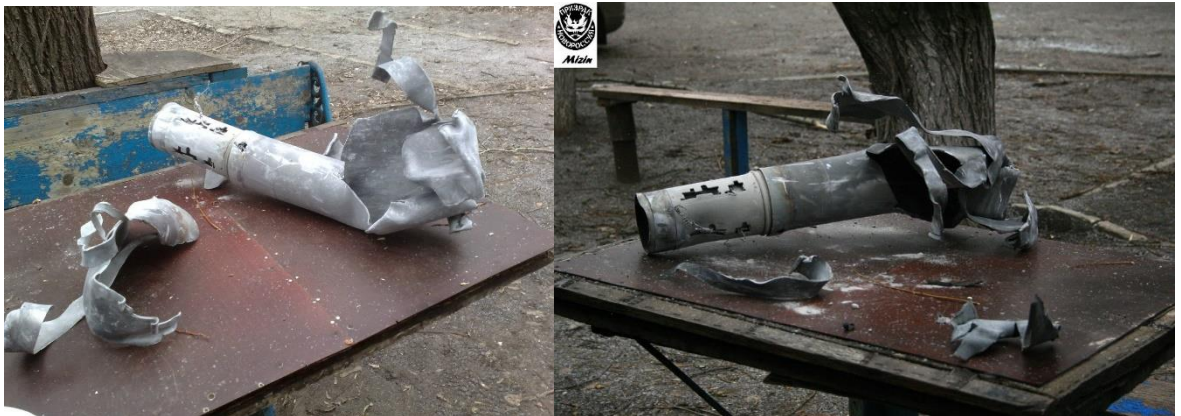
Fig. 26 - Remains of the rocket part of the 9K51 Grad MLRS projectile found at the site of shell hit 9⁴⁴.

The remnants of the rocket part of the 9K51 Grad MLRS projectile were found near the shell hit 10 (see Fig. 26).

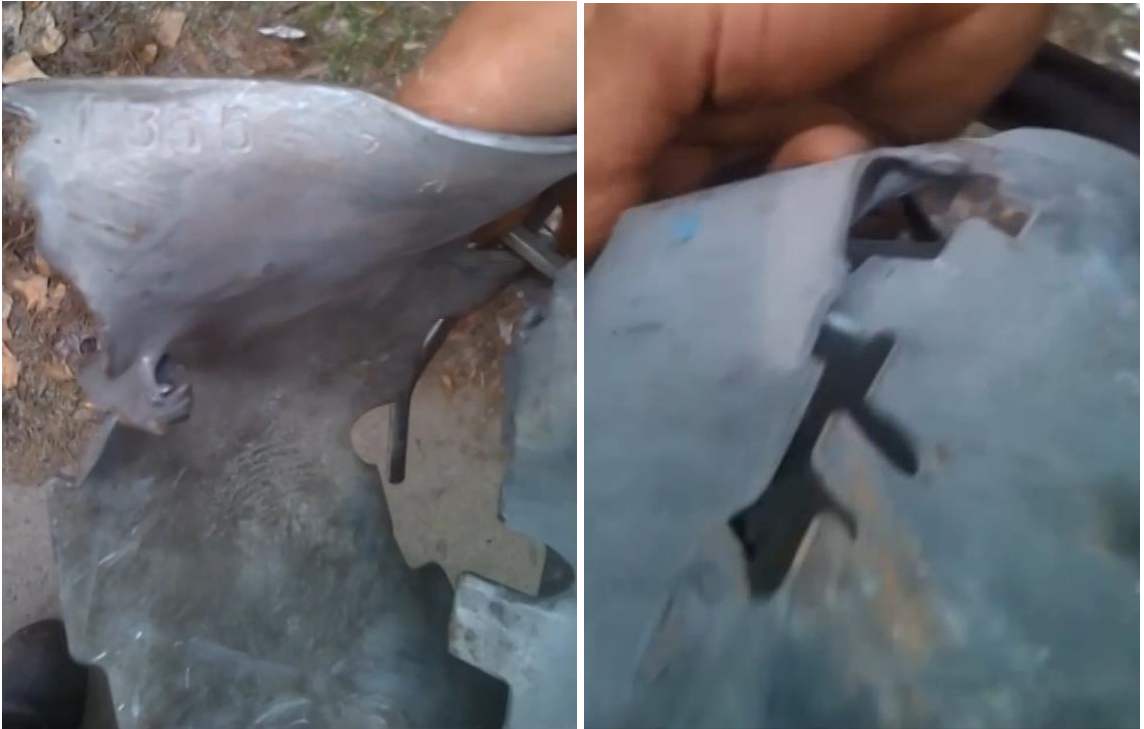
Fig. 27 - Remains of the rocket part of the 9K51 Grad MLRS projectile found at the site of shelling on 07.02.2015 in Kirovsk. The hole of the characteristic shape can be seen in the left figure; the hole of the characteristic shape, the rocket fin assembly and the embossed number “1355” are quite visible on the right.⁴⁵

There were holes of a specific shape on the remnants of the rocket part of the MLRS projectile found at the site of the shell hit No. 9. These holes located at the point of fin attachment to the body. Other remnants of the rocket part of the MLRS projectile with specific holes were also found in the area of the shelling (see 27). Such holes are characteristic precisely of 9K51 Grad MLRS shells. Let us consider the dummy stabilizer control units for MLRS shells used in the war in Donbass to confirm this thesis: 300-mm 9K58 Smerch (Windspout), 220-mm 9K57 Uragan (Hurricane) and 122-mm 9K51 Grad (Hail).

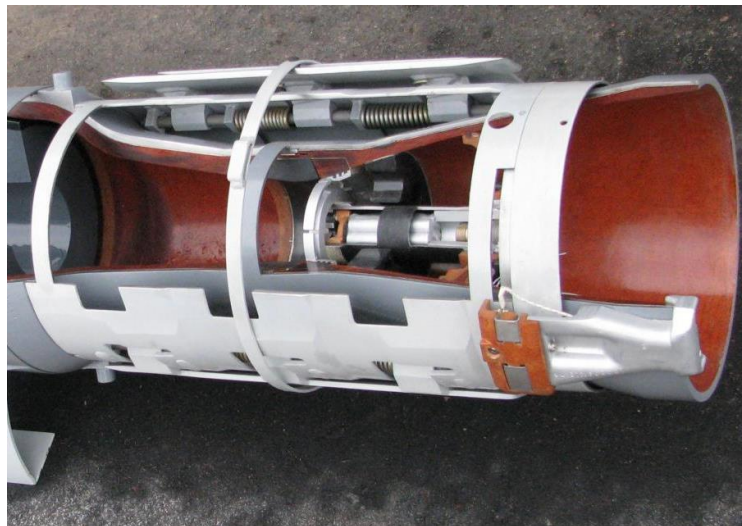
Fig. 28 - View of the tail assembly of the cutaway model of the Smerch MLRS projectile⁴⁶.

As can be seen in Fig. 28 and Fig. 29 three identical rectangular holes located at the same distance from each other are typical for attaching fins to the rocket part of the Smerch MLRS projectiles.
