Shelling of the town of Kirovsk using Grad MLRS on February 7, 2015.

PUBLIC INVESTIGATION

Donetsk 20.03.2022

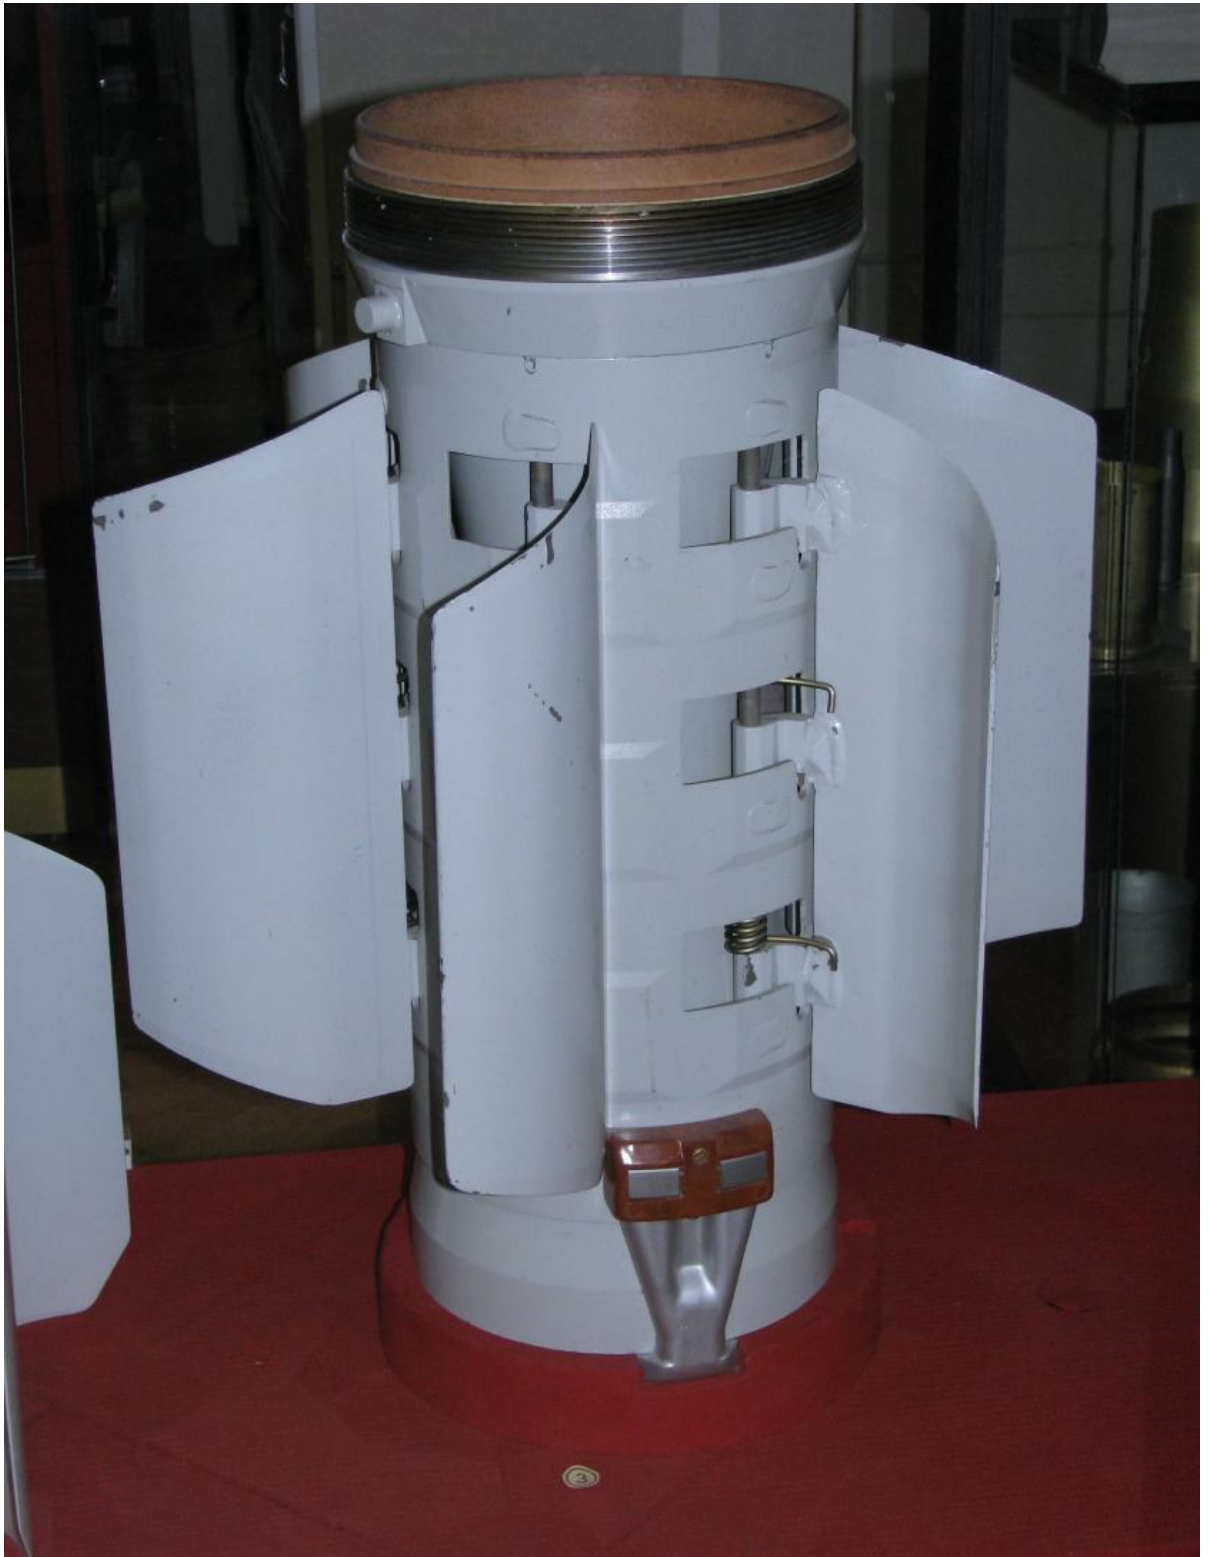
Fig. 29 - A dummy stabilizer control unit for the Smerch MLRS projectile⁴⁷.

As can be seen in Fig. 28 and Fig. 29 three identical rectangular holes located at the same distance from each other are typical for attaching fins to the rocket part of the Smerch MLRS projectiles.

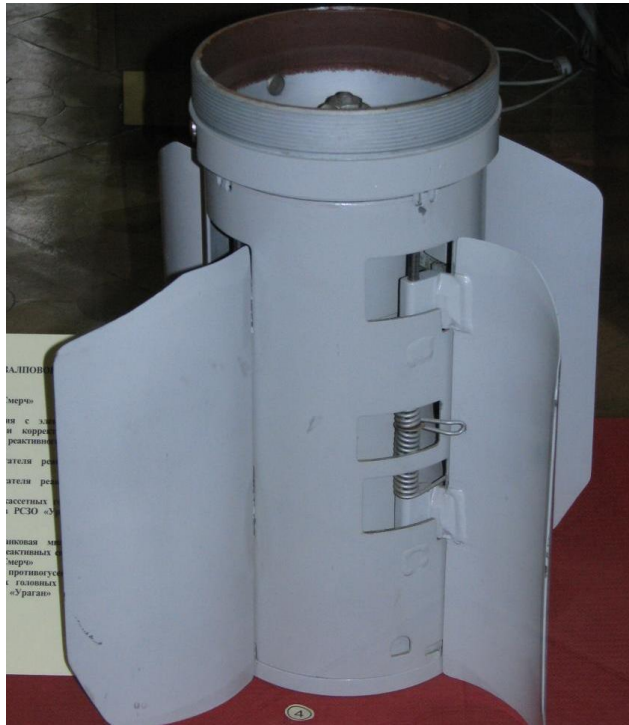
Fig. 30 – A dummy stabilizer control unit for the Uragan MLRS projectile⁴⁸.

In turn, the stabilizer control unit of the Uragan MLRS projectile also has three identical rectangular holes. However, they are located at different distances on these shells. And one of the holes (located in the middle) is smaller than the other two (see Fig. 30 and Fig. 31).

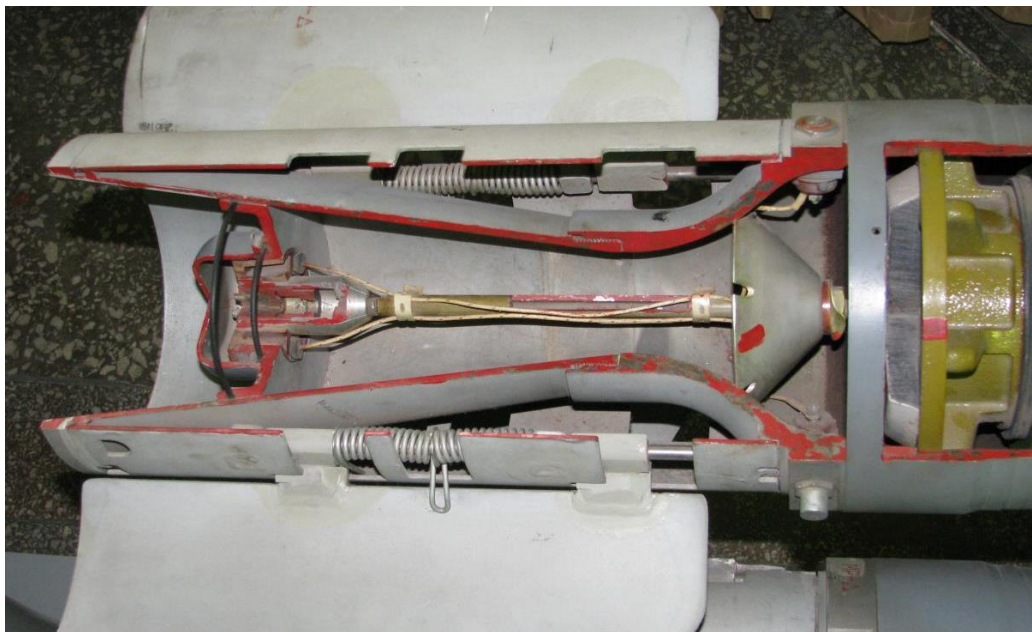
Fig. 31 – View of the tail assembly of the cutaway model of the Uragan MLRS projectile⁴⁹.

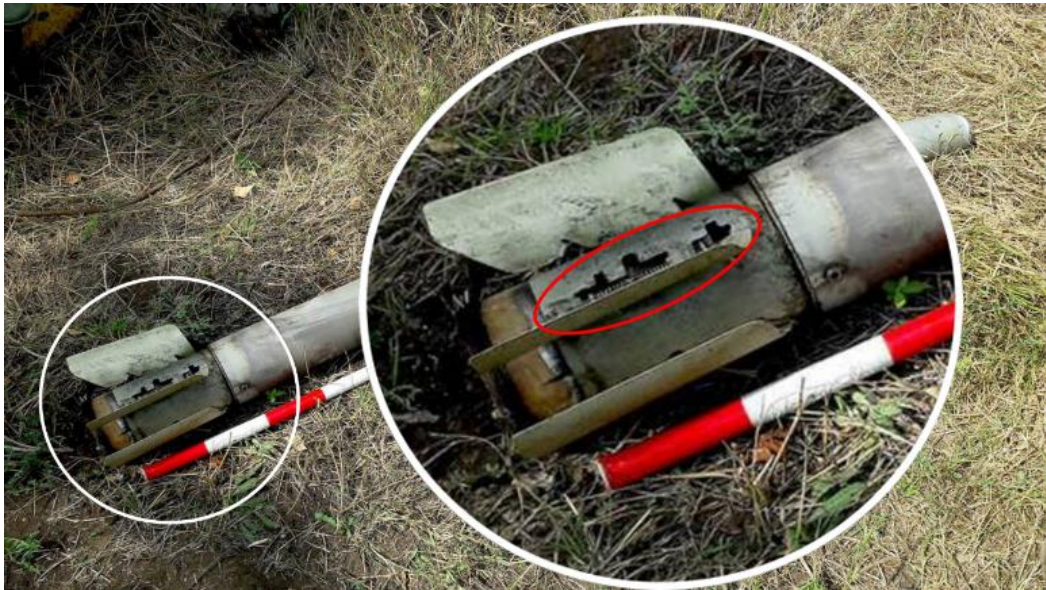
Fig. 32 – The remains of the 9K51 Grad MLRS projectile found near Krasnohorovka town on 28.08.2016.⁵⁰

Moreover, the same holes can be seen on the remains of the unexploded Grad projectile found near Krasnohorovka (see Fig. 32), and on the drawing of the 9K51 Grad MLRS projectile stabilizer unit (see Fig. 33).

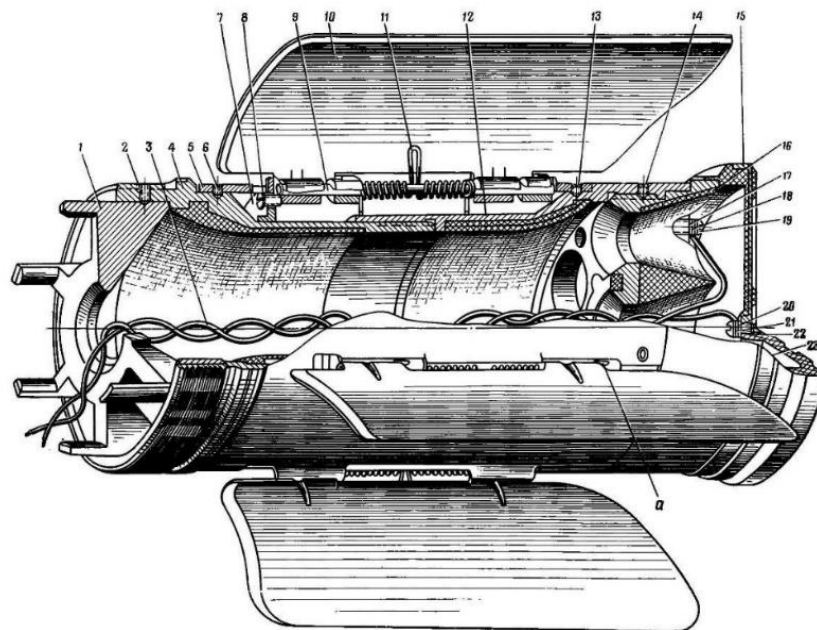
Рис. 101. Блок стабилизатора:
 1 – хвостовая диафрагма; 2 – установочный винт; 3 – провод; 4 – передний конус; 5 – обтекатель; 6 – установочный винт; 7 – кольцо; 8 – винт; 9 – ось; 10 – лопасть стабилизатора; 11 – пружина; 12 – задний конус; 13 – установочный винт; 14 – установочный винт; 15 – контактный сектор; 16 – крышка сошка; 17 – шайба; 18 – пружинная шайба; 19 – контактный винт; 20 – шайба; 21 – пружинная шайба; 22 – контактный винт; 23 – контактная крышка; а – паз

Fig. 33 – The drawing of the 9K51 Grad MLRS projectile stabilizer unit from the book *BM-21 GRAD*⁵¹.

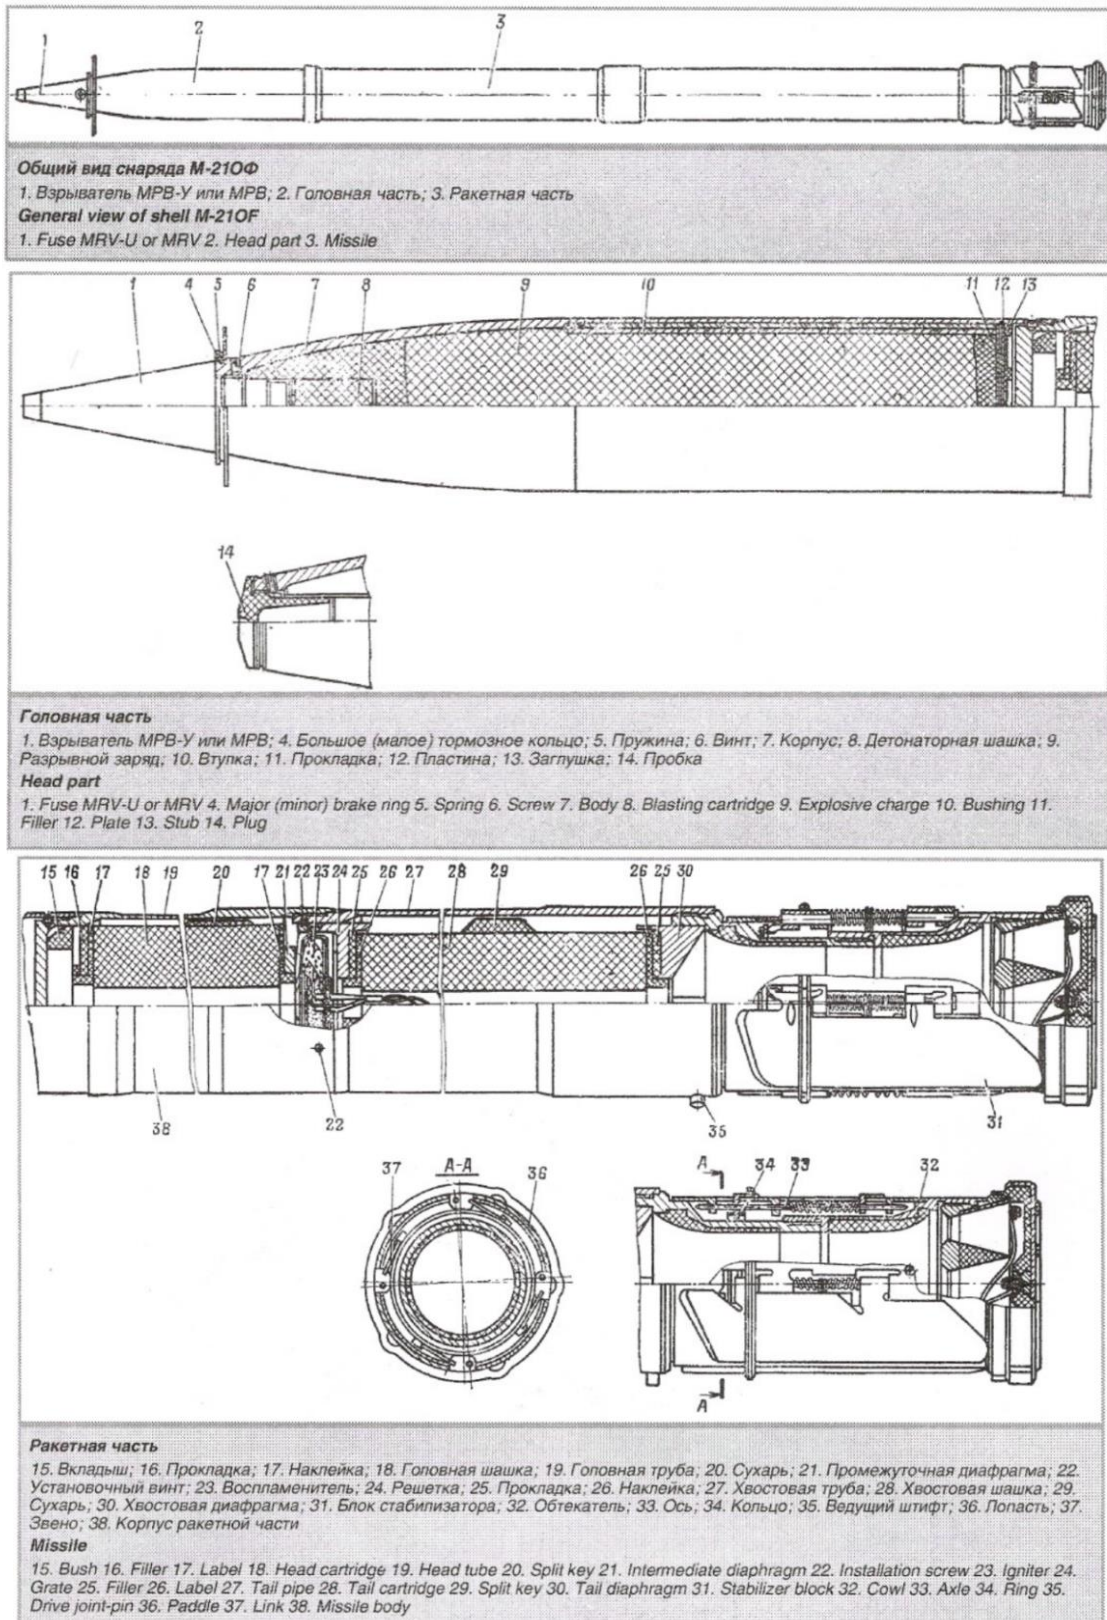
Fig. 34 - M-21OF projectile design (a high explosive fragmentation projectile, used for firing from 9K51 Grad MLRS)⁵².

The projectile for firing from 9K51 Grad MLRS consists of a fuze, head and rocket parts. As a result of contact with an obstacle, the detonator initiates an explosion of the shell head, which scatters into fragments (see Fig. 34).

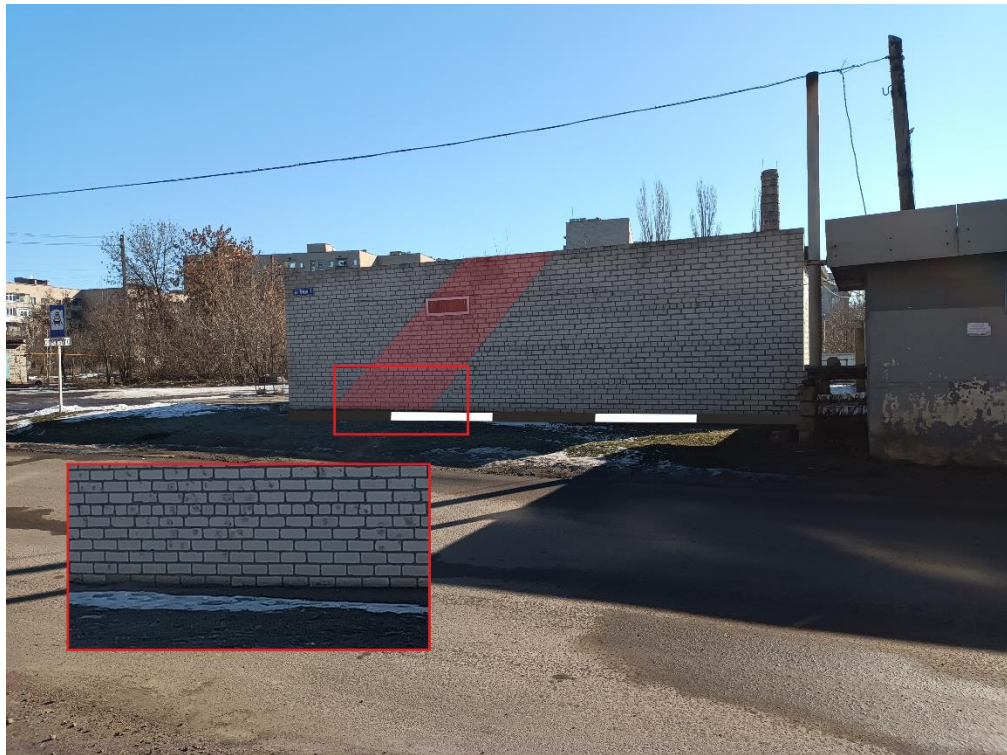
Fig. 36 – The line of the main scatter of fragments on the car wash building as a result of shell hit 8.

- on the car wash building (at 8, Pravda Str.) (see Fig. 36) the trace from the main scatter of fragments is in contact with the ground surface at a distance of 1/5 of the total width of the wall from the northern corner of the building;

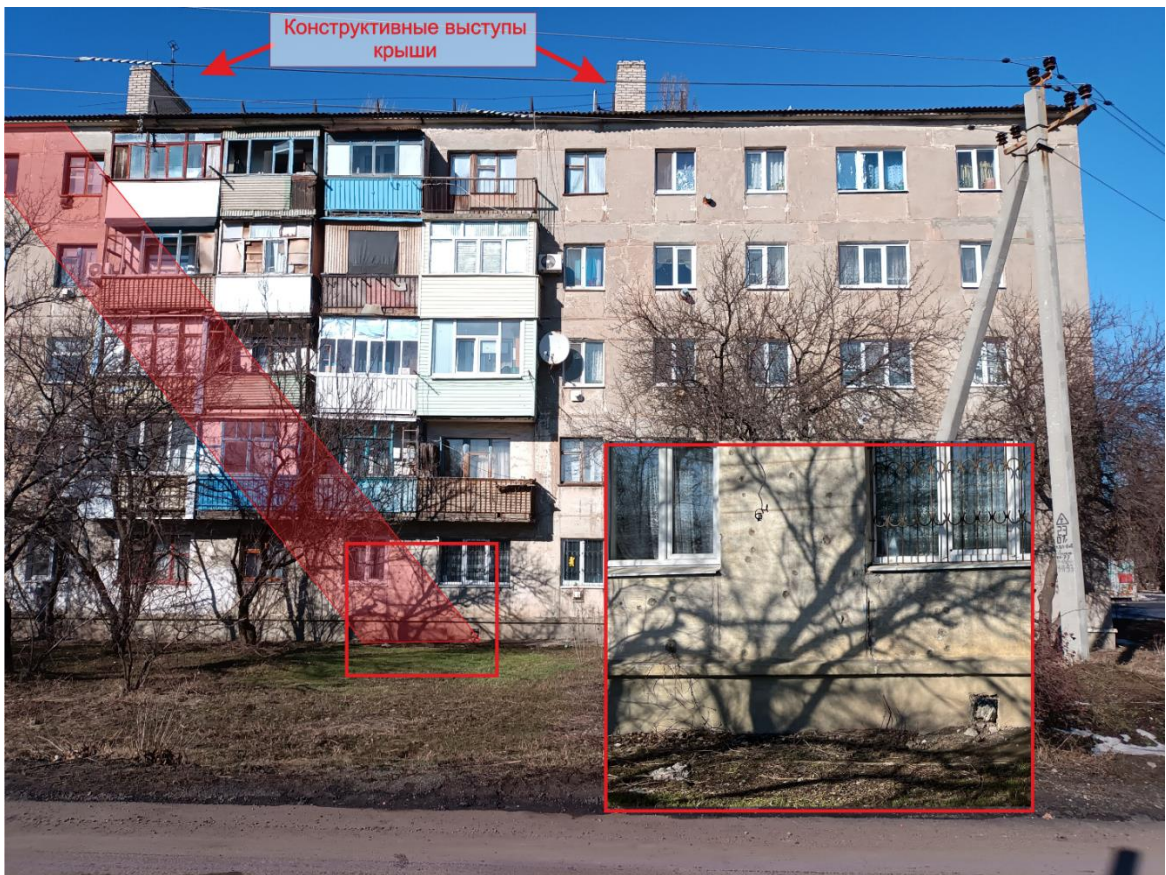
Fig. 37 - The line of the main scatter of fragments on the residential building as a result of shell hit 8.

- on the residential building (at 1, 50 years of the USSR Quarter), the line of the fragmentation trail is in contact with the ground surface under the balconies (see. Fig. 37); At the same time, this point is located approximately in the middle between two structural ledges of the roof of the building.

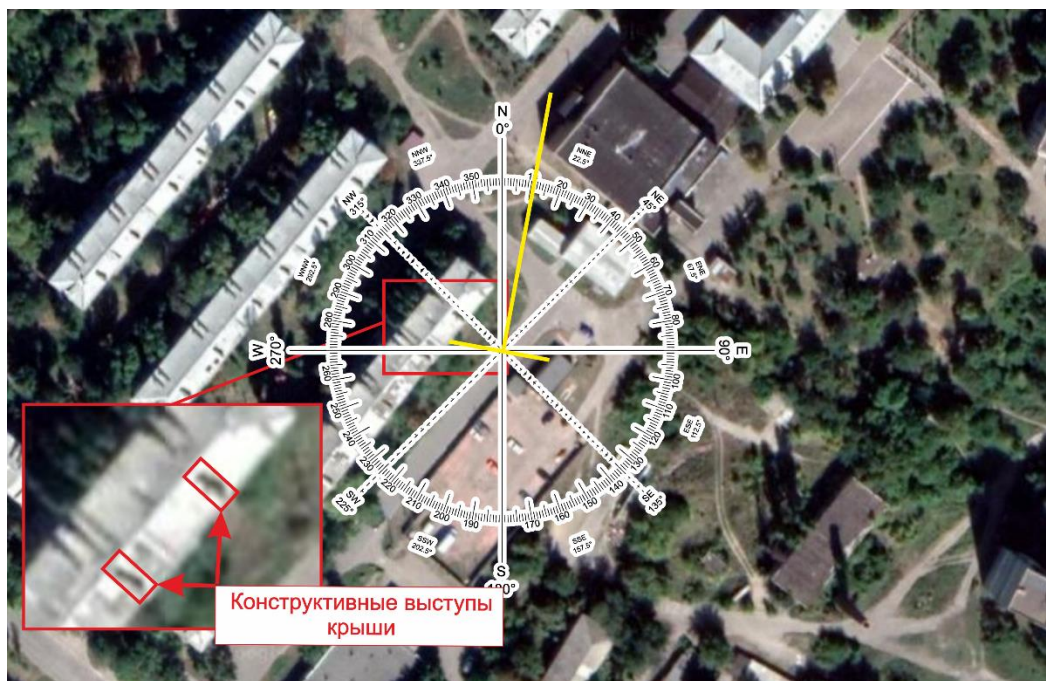
Fig. 38 – Determination of the direction from which the shelling was carried out on February 07, 2015.

On the satellite image, we can see the aforementioned structural ledges, and the car wash building. These findings allow us to mark the above points on the satellite image and draw a line between them (see Fig. 38), which is perpendicular to the direction of the projectile flight. Thus, it can be argued that the shelling was carried out from the north to south along the azimuth of 10 degrees.
